BELZONA GETS TO GRIPS WITH SAFETY AT AN INTERNATIONAL CONFERENCE CENTRE

ID: 786

Customer Location: *International Conference Centre-UK*
 Application Date: *June 2003*

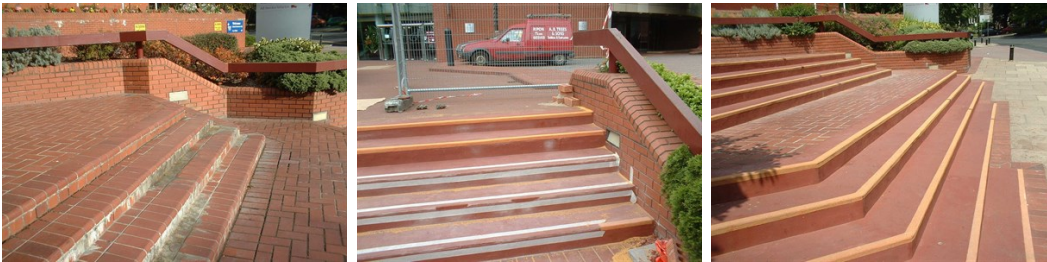
Photograph Descriptions

The finish on the tiles which made up the steps was a slip hazard when wet. In addition to this the steps were subjected to heavy foot traffic and misuse by skateboards, necessitating renovation to a condition reflecting the status of the International Conference Centre.

- * Original condition of the entrance steps. ,
- * Safety Grip areas masked off. ,
- * The finished application. ,
- * Application after 6 years of service. ,

The application was carried out in accordance with Belzona Know-How System Leaflets FPA-1 and FPA-8.

The customer was extremely pleased with the aesthetic appearance of the application, which aside from meeting their safety needs, matched the Organisations Logo. After 6 years of arduous service Belzona is still providing excellent performance and the rough surface prevents damage from skateboarders.
