# Belzona saves a corroded airtight compartment

ID: 7860

Industry: Marine  
Application: SOS-Ships and Offshore Structures

Airtight compartment on a shipyard

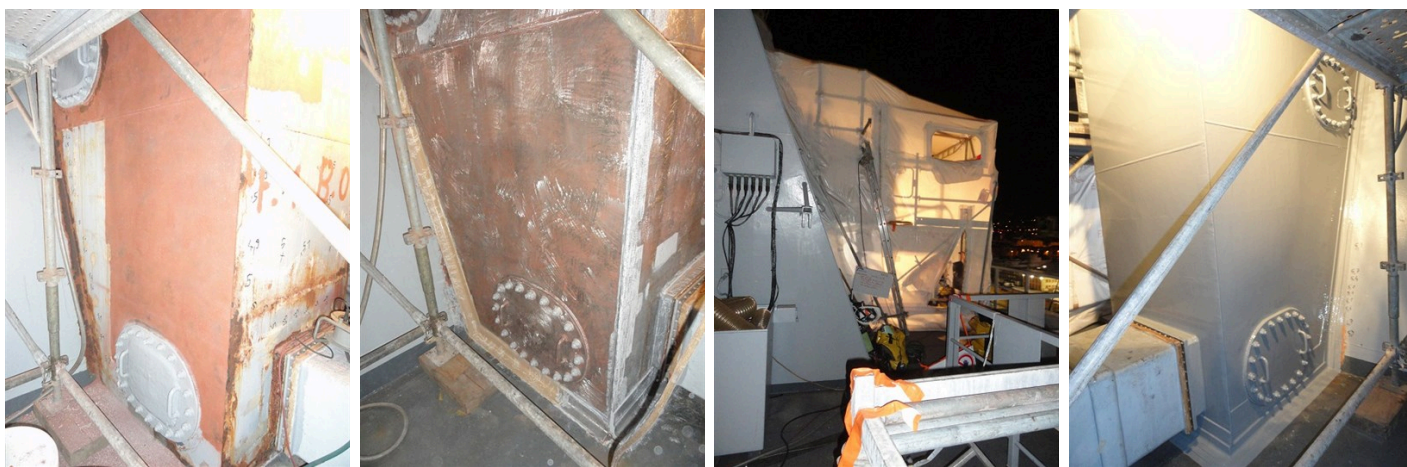
*This compartment filled with air and used for underwater works was badly corroded and needed to be repaired and protected.*

\* 1- Before application 2- After surface preparation 3- Installation for the application 4- Final result ,

After carefully preparing the surface by grit blasting, the most damaged parts of the equipment were repaired by bonding metal plates with Belzona 1161. After that, two coats of Belzona 5811 were applied to protect the whole surface against corrosion.
