# Belzona Repairs Ball Mill Foundations at a Gold Mine

Concrete ball mill foundations.

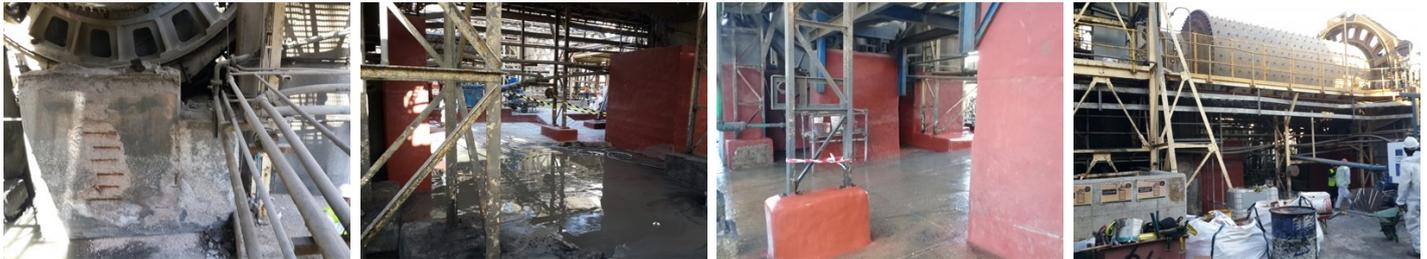
The concrete ball mill foundations degraded over time due to vibrations and warm environment.

- \* Before application ,
- \* During the application ,
- \* Final application ,
- \* Overview of the equipment ,

The substrate was first prepared by grit blasting prior to the installation of steel reinforcement bars. Belzona 4911 was then applied on the whole surface followed by Belzona 4131. The application was carried out in accordance with a modified version of Belzona Know-How System Leaflets FPA-1 and FPA-3.
