# Belzona Keeps a Floating Hose Afloat

ID: 7863

Industry: *Oil & Gas*  
Application: *SOS-Ships and Offshore Structures*

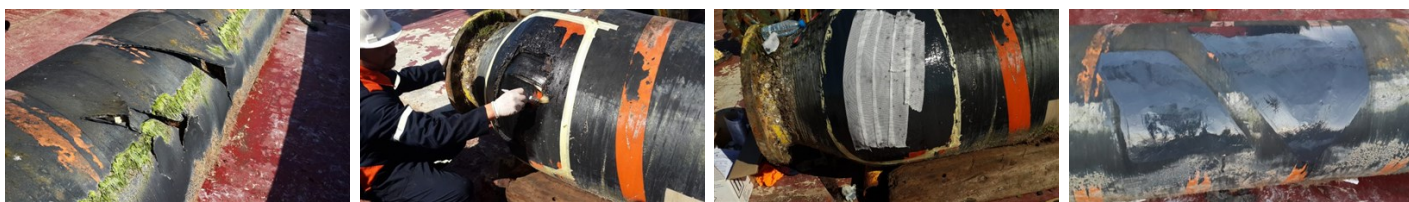
*A floating hose got severely damaged due to a collision with a ship's propeller*

- \* Damaged hose before the application. ,
- \* Application of Belzona 2211. ,
- \* Use of Belzona 9341 (Reinforcement Sheet) ,
- \* Complete application. ,

The application was carried out in accordance with a modified version of Belzona Know-How System leaflet SOS-12. Any loose rubber was cut away, then the application area was prepared with a roughing brush. Belzona 2211 was then used with a Belzona 9341 reinforcement sheet to reinforce the damaged area.
