# Oil Tank Leak- Power Plant

ID: 7865

Steel tank Oil Reservoir

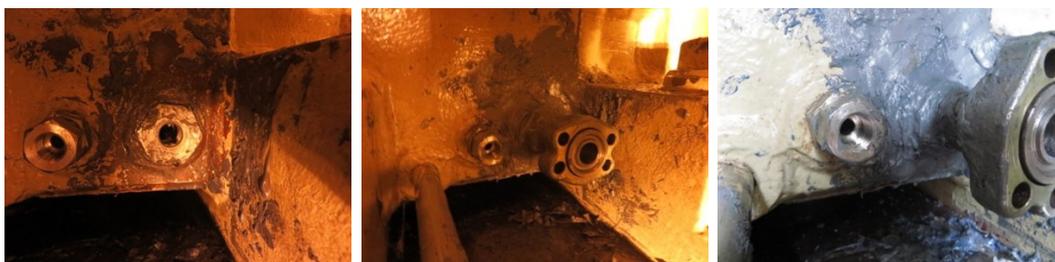
The down deck of the tank had been subjected to severe corrosion leading to drips leak of the oil. This needed to be fixed urgently for the plant to continue operating and also avoid environmental hazards from leaking oil.

- \* Oil tank leak area ,
- \* During application of Belzona 1212 to the pinhole on the oil tank ,
- \* Belzona 1212 application completed. ,

Surface was blasted using Bristle Blaster to remove existing paint and achieve minimum surface profile and cleanliness. Belzona 1212 was applied to seal the leak by cold bonding. Belzona 1212 was re-applied when the first coat reaches its pre-curing time. This application was done overnight because client needed the tank ready in the morning to receive product and thus no plant shutdown.
