# Condenser Rubber liner repaired with Belzona

Customer Location: Power plant - Takoradi, Ghana  
Application Date: October 2018

Rubber liner of a Steam Condenser

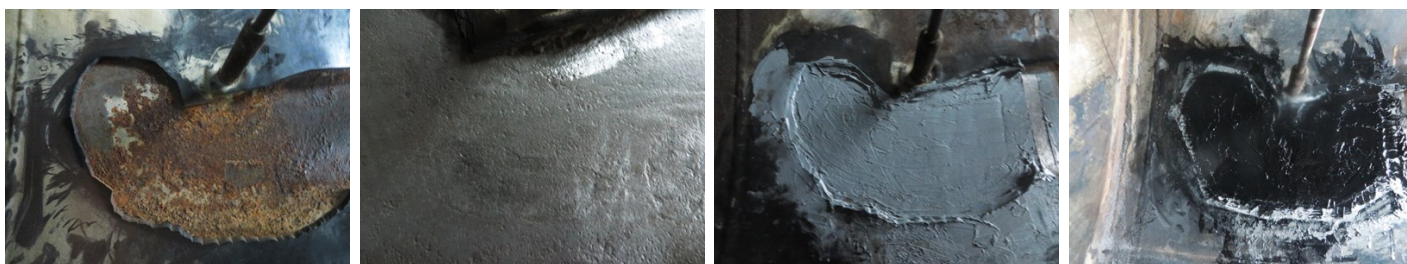
Existing condenser rubber liner peels off and corrosion starts to attack the metallic surface.

- \* Before the surface prep and application of Belzona 2111 and Belzona 1111 ,
- \* After Surface preparation using bristle blaster ,
- \* After the application of Belzona 1111 ,
- \* After view when Belzona 2111 was applied ,

Application was done in accordance with Belzona System leaflets GSS-1 creating gaskets. After surface was prepared, we notice some amount of metal has been lost. Metallic surface was rebuilt with Belzona 1111. Elastomeric conditioner was applied on the next day, then Belzona 2111 (D&A High-Build Elastomer) was applied, using an applicator and brush.

The rubber liner was rebuilt with Belzona 2111 and is currently lasting and performing well when steam condenser is in service. The cost to repair is lower as compared to purchasing a new steam condenser for power generation. Belzona 2111 (D&A High-Build Elastomer) was selected because of the properties with respect to operating parameters.
