Belzona Realigns a Pump in a Chemical Plant

ID: 7871

Industry: *Chemical & Petrochemical*
 Application: *SOS-Ships and Offshore Structures*

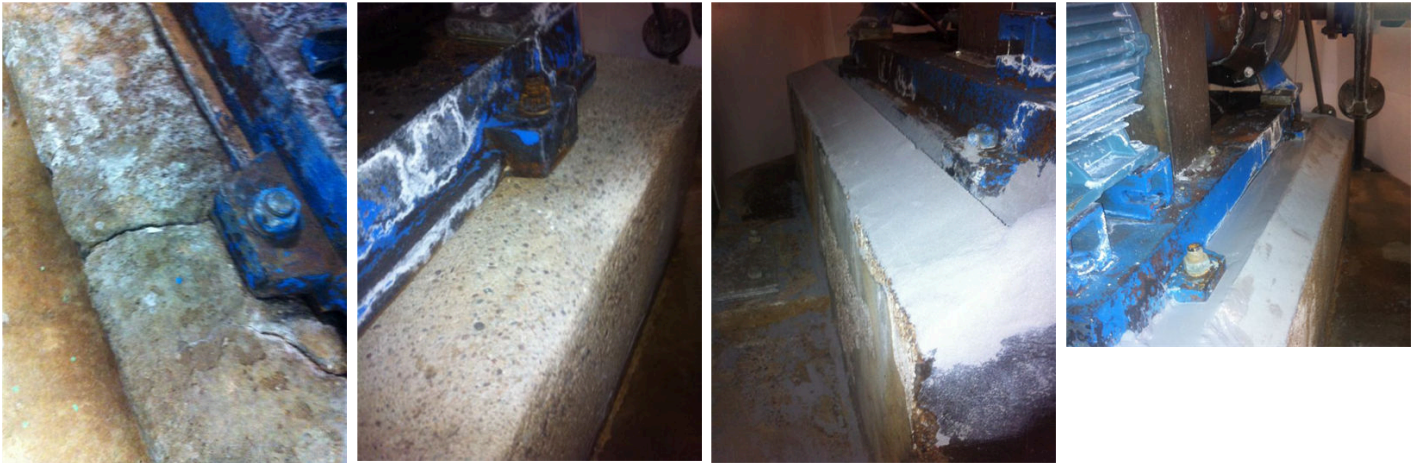
Photograph Descriptions

A pump sitting on a concrete block was no longer properly aligned causing shear stress.

- * Showing damage. ,
- * After the surface preparation. ,
- * Belzona 4111 applied. ,
- * Belzona 7111 applied. ,

Damaged concrete block underneath a pump.

All the broken pieces of concrete were taken off the concrete block, then, the surface of the steel and the remaining concrete were prepared. A thin layer of Belzona 4911 was then applied and allowed to become touch dry. A wooden frame was used to rebuild the

concrete block with Belzona 4111 first. Then, Belzona 7111 was poured into the remaining space between Belzona 4111 and the equipment. The application was carried out in accordance with a modified version of Belzona System Leaflet SOS-8.

After 18 months in service, the equipment was still perfectly aligned.
