Dewatering Centrifuge Scroll Rebuilding and Protection with Belzona

ID: 7872

Customer Location: Wastewater Treatment Plant, Riyadh,
Saudi Arabia

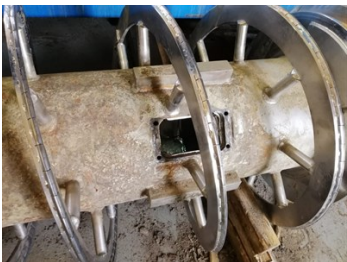
The Dewatering Centrifuge Scroll was damaged and metal chunks were broken due to aggressive wear and abrasion of waste material. All this lead to the client taking it out of service

- * 1. The Dewatering Centrifuge Scroll ,
- * 2. A close up of the damage ,
- * 3. Rebuilt with Belzona 1311 ,
