Internal refecton of a centrifugal pump using Belzona

Application: CEP-Centrifugal Pumps

Substrate: Cast Iron

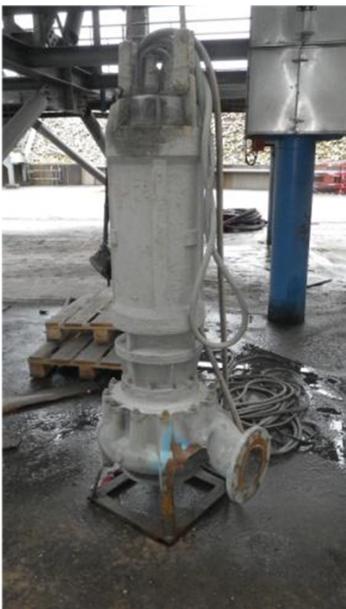
The inside of this pump was badly damaged by entrained solids as it pumps river water. The high speed of the fluid also accelerated the deterioration.

- * 1- Overview of the equipment ,
- * 2- Zoom on the main defect on the discharge outlet ,
- * 3- Reinforcement with the metallic net ,
- * 4- Final application ,

The substrate was first prepared by grit blasting, then Belzona 1111 was used to rebuild the concentric area. It was then machined to get the right tolerances. The discharge outlet was rebuilt from the outside using a metallic mesh and Belzona 1311 and protected with Belzona 1811. Finally the inside of the pump was protected with Belzona 1341.
