# Internal refection of a centrifugal pump using Belzona

ID: 7873

Industry: Fluid Flow  
Application: CEP-Centrifugal Pumps  
Substrate: Cast Iron  
Products: \* Belzona 1111 (Super Metal) ,  
\* Belzona 1311 (Ceramic R-Metal) ,  
\* Belzona 1811 (Ceramic Carbide) ,  
\* Belzona 1341 (Supermetalgilde) ,

Customer Location: France  
Application Date: March 2014

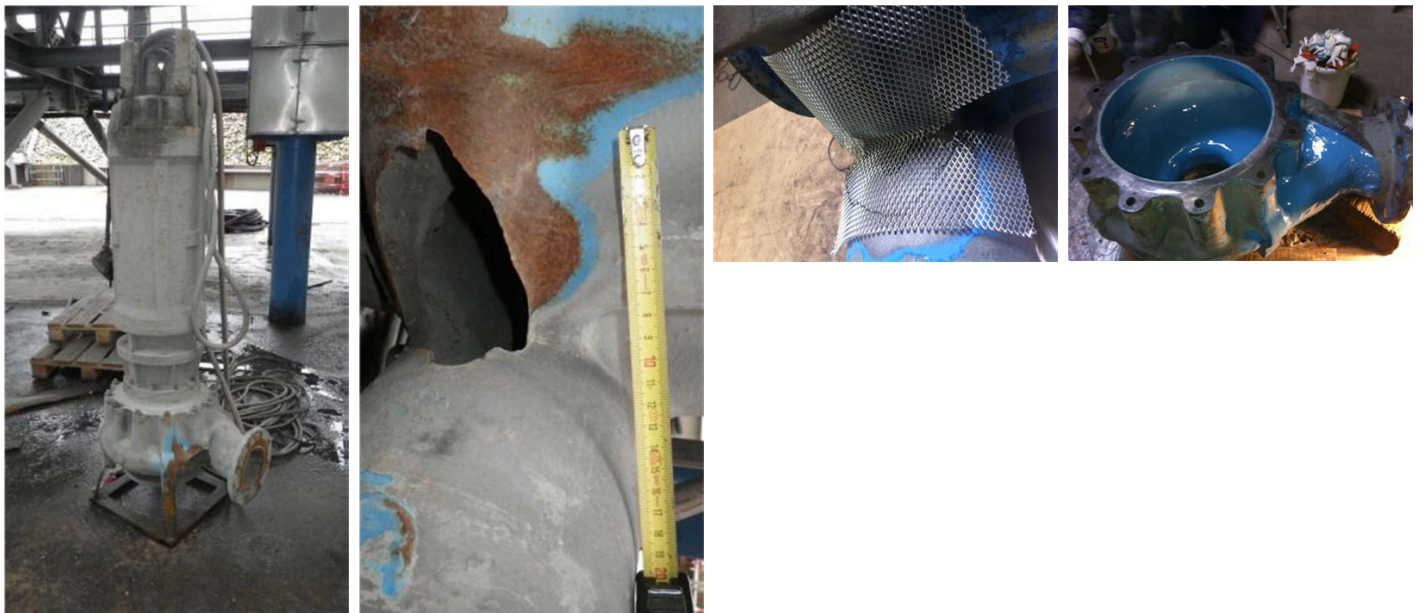
The inside of this pump was badly damaged by entrained solids as it pumps river water. The high speed of the fluid also accelerated the deterioration.

- \* 1- Overview of the equipment ,
- \* 2- Zoom on the main defect on the discharge outlet ,
- \* 3- Reinforcement with the metallic net ,
- \* 4- Final application ,

The substrate was first prepared by grit blasting, then Belzona 1111 was used to rebuild the concentric area. It was then machined to get the right tolerances. The discharge outlet was rebuilt from the outside using a metallic mesh and Belzona 1311 and protected with Belzona 1811. Finally the inside of the pump was protected with Belzona 1341.
