# Belzona Forms the Faces of 132 Sea Water Flanges

**Customer Location:** Petrochemical Plant, Saudi Arabia  
**Application Date:** 2018

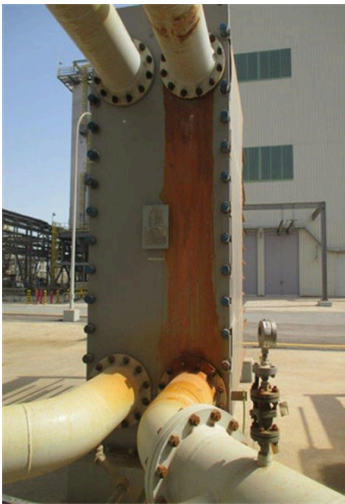
A new utility sea water cooling facility was commissioned 1 year ago for this plant. Already, the effects of sea water were leading to crevice corrosion on many diameters of pipe line flanges. This was leading to worn out serrations and severe damages on the seating faces. Existing FBE coating failure inside the spools was due to sea water penetration and pitting corrosion on the edges of spool. Leakages observed through various flange faces / weld seams were leading to intermittent shutdowns.

- \* 1. Sea water leaking through the flanges ,
- \* 2. Flange damage on the edges ,
- \* 3. Application of Belzona 1111 (Super Metal) on the flange to form peaks ,
- \* 4. 48 inch completed application ,
