Belzona Forms the Faces of 132 Sea Water Flanges

Customer Location: Petrochemical Plant, Saudi Arabia
Application Date: 2018

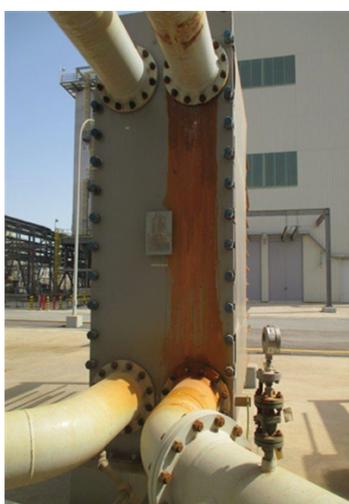
A new utility sea water cooling facility was commissioned 1 year ago for this plant. Already, the effects of sea water were leading to crevice corrosion on many diameters of pipe line flanges. This was leading to worn out serrations and severe damages on the seating faces. Existing FBE coating failure inside the spools was due to sea water penetration and pitting corrosion on the edges of spool. Leakages observed through various flange faces / weld seams were leading to intermittent shutdowns.

- * 1. Sea water leaking through the flanges ,
- * 2. Flange damage on the edges ,
- * 3. Application of Belzona 1111 (Super Metal) on the flange to form peaks ,
- * 4. 48 inch completed application ,
