Rubber Lined Condenser Water Box Repair Requires Belzona

ID: 7880

Customer Location: Power Plant, Western Region of Saudi Arabia

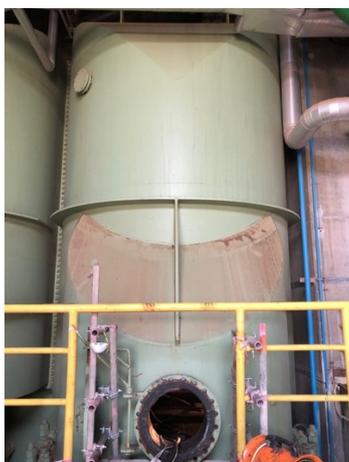
* 1. Application overview 2. Close up of damage showing erosion and cavitation damage 3. The water box repaired with Belzona 1311 (Ceramic R-Metal) ,

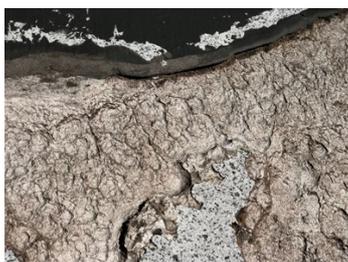
Inspection during the Power Plant shutdown showed severe erosion on the rubber-lined condenser water box, with thickness loss of around 5-6 millimeters in localised areas.
