Rubber Lined Condenser Water Box Repair Requires Belzona

Customer Location: Power Plant, Western Region of Saudi Arabia

Condenser Water Box

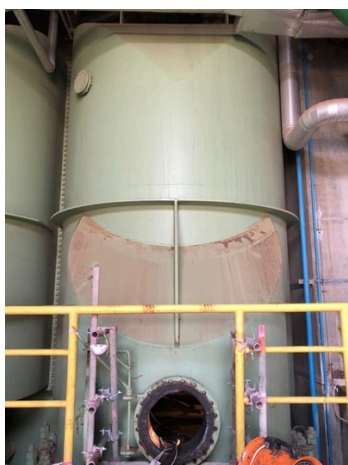
* 1. Application overview 2. Close up of damage showing erosion and cavitation damage 3. The water box repaired with Belzona 1311 (Ceramic R-Metal) ,

The repair was completed in accordance with system leaflet WPA-1. The rubber was undercut and all loose surface contamination was removed. After achieving correct surface preparation, Belzona 1311 (Ceramic R-Metal) was applied and contoured to the required profile.

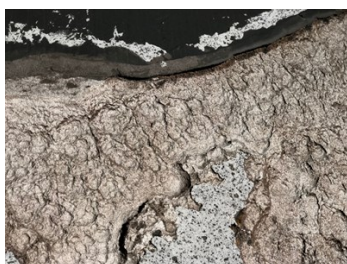
Inspection during the Power Plant shutdown showed severe erosion on the rubber-lined condenser water box, with thickness loss of around 5-6 millimeters in localised areas.
