Rubber Lined Condenser Water Box Repair Requires Belzona

ID: 7880

Customer Location: Power Plant, Western Region of Saudi Arabia

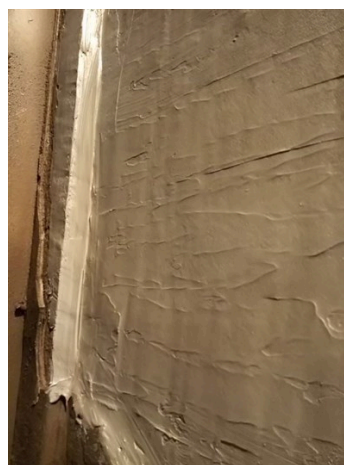
* 1. Application overview 2. Close up of damage showing erosion and cavitation damage 3. The water box repaired with Belzona 1311 (Ceramic R-Metal),

One year later, the application is performing very well and working without any problems.

The repair was completed in accordance with system leaflet WPA-1. The rubber was undercut and all loose surface contamination was removed. After achieving correct surface preparation, Belzona 1311 (Ceramic R-Metal) was applied and contoured to the required profile.
