# Belzona Internal Coating Protection for 3 Condensers and Absorbers

Customer Location: Energy, Operation and Maintenance company, Jeddah, Saudi Arabia

Application: HEX-Heat Exchangers

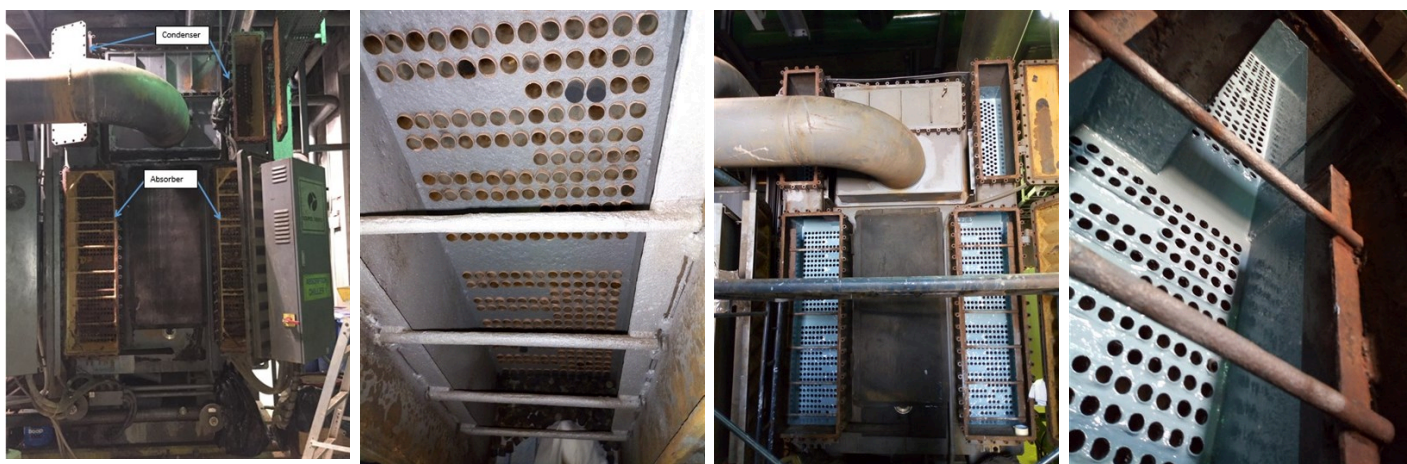
Tube sheets, water boxes and end covers were subject to high erosion-corrosion. As a result of galvanic corrosion and chemical attack, they were severely corroded.

- \* 1. A condenser and absorber before ,
- \* 2. Application in progress ,
- \* 3. The completed application ,
- \* 4. Close up of the completed application ,

The application was carried out in accordance with Belzona Know-How System Leaflets HEX-1 and HEX-3. After grit blasting, erosion damage & pitting were rebuilt, prior to applying Belzona 1391T for overall corrosion and chemical attack protection.
