Belzona Solution For Cooling Tower Water Circulation Pumps

Customer Location: *Petrochemicals Company, Saudi Arabia*

Application Date: *December 2015*

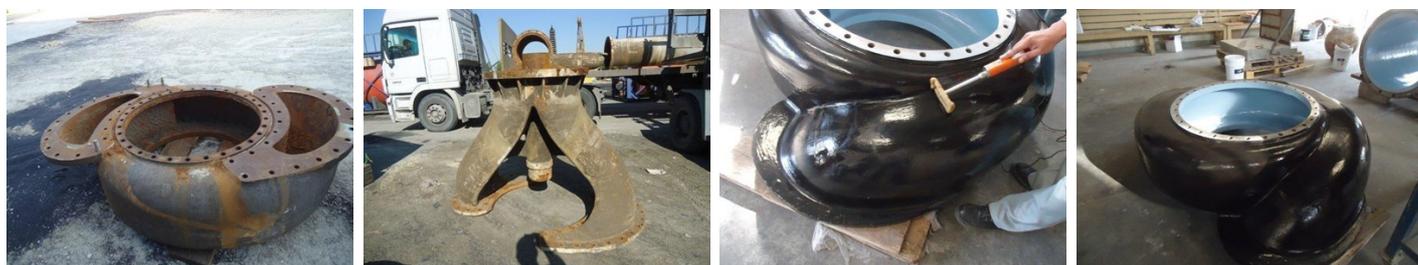
This Cooling Tower Water Circulation Pump was suffering from erosion and corrosion on all internal surfaces and corrosion on external surfaces

- * Damage beforehand ,
- * Damage beforehand ,
- * Application in progress ,
- * Completed application ,

The applications were undertaken in accordance to modified versions of Belzona Know-How System Leaflets CEP-5, CEP-3, CEP-4. Belzona 1111 was applied directly over the blasted metal surface to rebuild weld joints, pitting, depression and eroded surface. For internal surfaces, apply two-coats with Belzona 1341. For External surfaces, the surface was primed with Belzona 3921 two coats of Belzona 5811 were applied.
