Belzona Solution For Cooling Tower Water Circulation Pumps

ID: 7885

Customer Location: Petrochemicals Company, Saudi Arabia

Application Date: December 2015

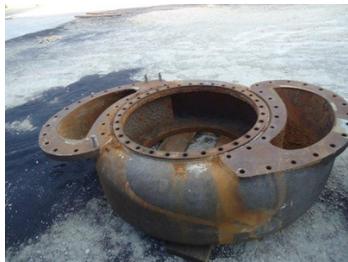
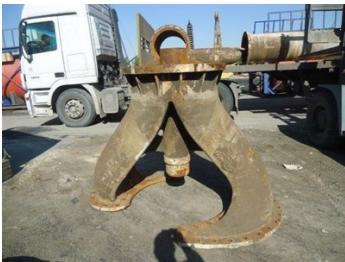
This Cooling Tower Water Circulation Pump was suffering from erosion and corrosion on all internal surfaces and corrosion on external surfaces

- * Damage beforehand ,
- * Damage beforehand ,
- * Application in progress ,
- * Completed application ,

The applications were undertaken in accordance to modified versions of Belzona Know-How System Leaflets CEP-5, CEP-3, CEP-4. Belzona 1111 was applied directly over the blasted metal surface to rebuild weld joints, pitting, depression and eroded surface. For internal surfaces, apply two-coats with Belzona 1341. For External surfaces, the surface was primed with Belzona 3921 two coats of Belzona 5811 were applied.
