# Belzona Offers a Peace of Mind to a Private Villa Owner

**Industry:** Buildings & Structures  
**Application:** FPA-Floor Problem Areas  
**Substrate:** Concrete  
**Products:** \* Belzona 4111 (Magma Quartz),  
\* Belzona 5891 (HT Immersion Grade),

**Customer Location:** Saudi Arabia  
**Application Date:** 2017

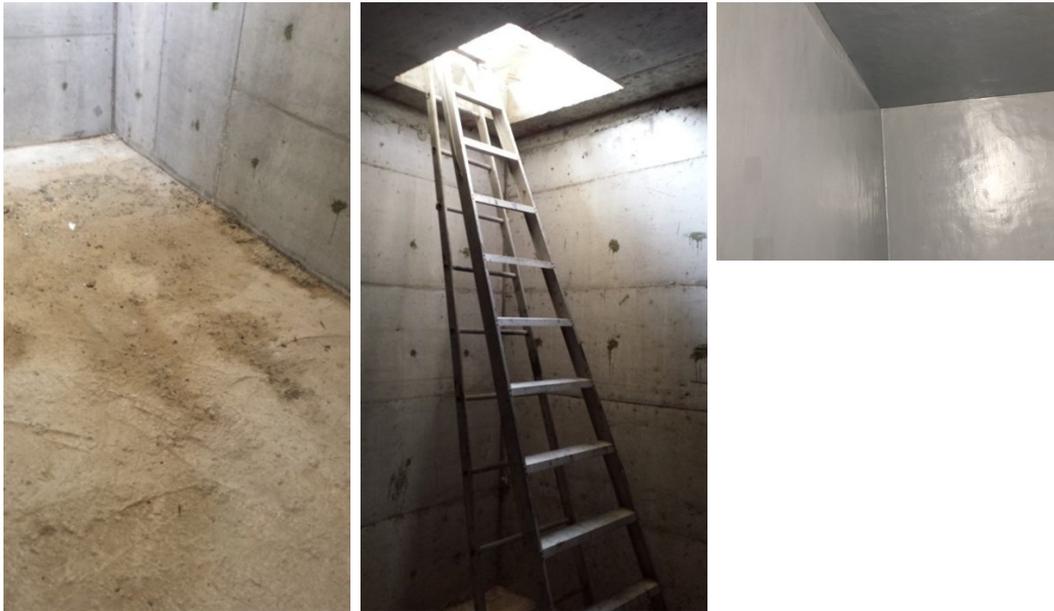
Poorly finished concrete walls and floors.

- \* The potable water tank before the application. ,
- \* Another view of a tank before the application. ,
- \* Complete application. ,

The application was carried out in accordance with a modified version of Belzona Know-How System Leaflet FPA-1, Belzona 4111 was used to repair the poorly finished concrete walls and floors of the tanks and Belzona 5891 was used to coat the internal

surfaces of the tanks.

The customer was satisfied with both the product finish and the way the repair and coating were carried out. After the initial cleaning the water was crystal clear and odourless. The tanks were opened after a 1 year in service for cleaning and the coatings were found sound and intact.
