Belzona Offers a Peace of Mind to a Private Villa Owner

ID: 7886

Application: *FPA-Floor Problem Areas*

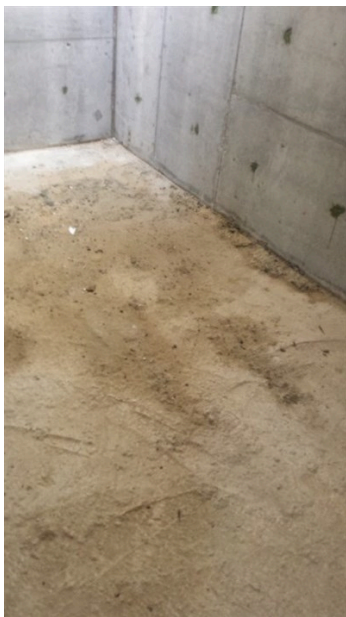
Poorly finished concrete walls and floors.

- * The potable water tank before the application. ,
- * Another view of a tank before the application. ,
- * Complete application. ,

The application was carried out in accordance with a modified version of Belzona Know-How System Leaflet FPA-1, Belzona 4111 was used to repair the poorly finished concrete walls and floors of the tanks and Belzona 5891 was used to coat the internal

surfaces of the tanks.
