# Belzona Relieves the Hospital Patients from the Heat

Customer Location: A private hospital, Saudi Arabia

A CPVC pipe crack was causing the leaking of cooling water from the air conditioning system

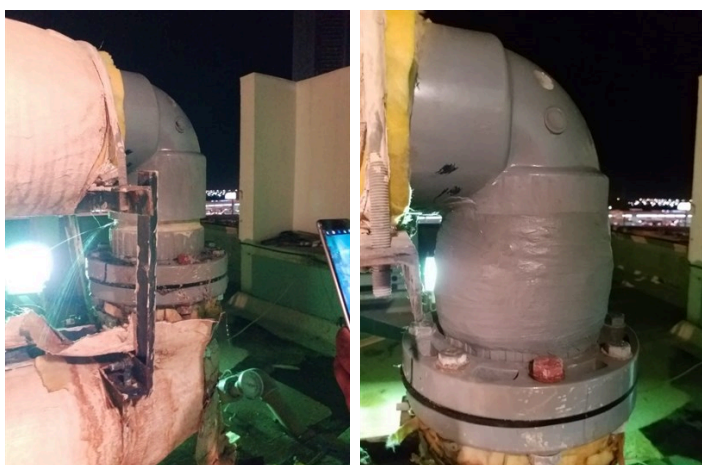
\* 1. Before the repair 2. After the repair ,

In accordance with Belzona System leaflet VPF-11. Belzona 9611 (ES Metal) was used to seal the crack initially. Then, Belzona 1212 was used to seal the crack and strengthen it to stop the leak completely. Belzona 1111 (Super Metal) was applied to wrap the repair incorporating Belzona 9341 (Reinforcement sheet) to reinforce the repair. The application was carried out at night, causing limited disruption to the air conditioning system by reducing the line pressure slightly without causing any discomfort to the Inpatients in the hospital.

A year later, the application is still in perfect condition
