BELZONAS CERAMIC SOLUTION FOR ELEPHANTS FEET

Customer Location: Korean Shipyard - 35,000 DWT Products Tanker

Application: TCC-Tanks and Chemical Containment Areas

Suction Wells under "Elephants Feet" in Chemical Products Tanker

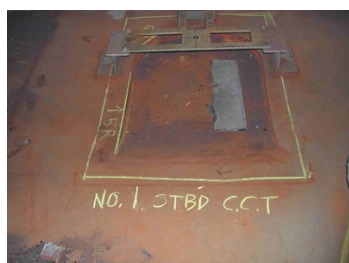
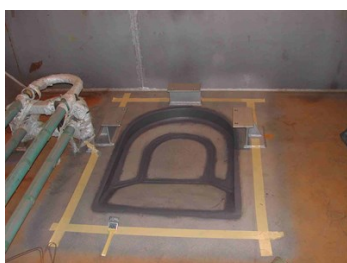
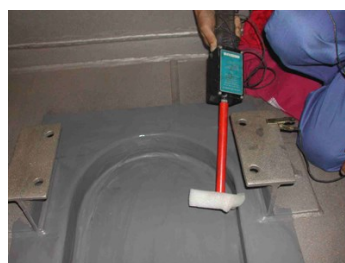
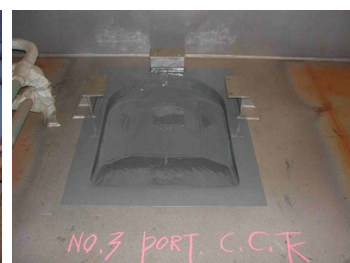
Photograph Descriptions

High fluid velocities combined with elevated temperatures and chemical products cause erosion-corrosion when tanks are filled or emptied.

- * Pre-application, showing areas to be radiussed ,
- * Belzona® 1311 used to stripe coat welds ,
- * Inspection of Belzona® 1391 ,
- * Completed Belzona® 1391 protected well ,

The Application was carried out in accordance with a modified version of Belzona Know-How System Leaflet TCC-5.

Belzona® 1391 was selected based upon its outstanding track record in high temperature erosion-corrosion protection, and further ships suction wells have been coated based upon the proven system.
