Repair of Concrete Support For Effluent Vessel

ID: 7890

Industry: Oil & Gas

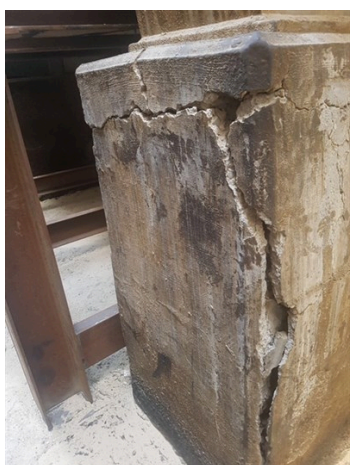
Damaged Concrete Supports of effluent water vessel: Water ingress and weathering had caused corrosion of the reinforcement bar leading to cracking and spalling of the concrete supports.

- * 1. Before application ,
- * 2. damaged and loose concrete was removed. ,
- * 3. Finished application ,
