# Belzona repairs and protects an SEC pump

Industry: Power  
Application: CEP-Centrifugal Pumps  
Substrate: Cast Iron  
Products: \* Belzona 1311 (Ceramic R-Metal) ,  
\* Belzona 1341 (Supermetalglide) ,

Cutwater of a SEC pump

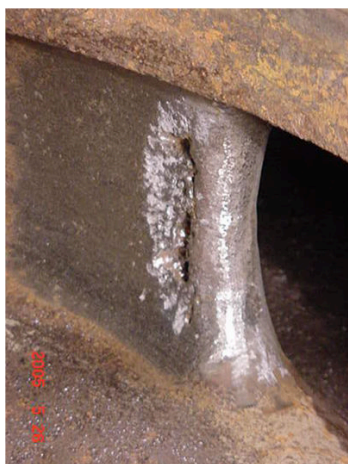
The cut-water of this pump was damaged by erosion/cavitation and needed to be rebuilt and protected.

- \* 1- Before application ,
- \* 2- Final application ,

The rebuilding step was done with Belzona 1311 in accordance to Belzona System Leaflet CEP-1. The area was then protected by overcoating with Belzona 1341.
