# Belzona repairs and protects an SEC pump

ID: 7895

Industry: *Power*  
Application: *CEP-Centrifugal Pumps*  
Substrate: *Cast Iron*  
Products: *\* Belzona 1311 (Ceramic R-Metal) ,*  
*\* Belzona 1341 (Supermetalglide) ,*

Customer Location: *France*  
Application Date: *May 2005*

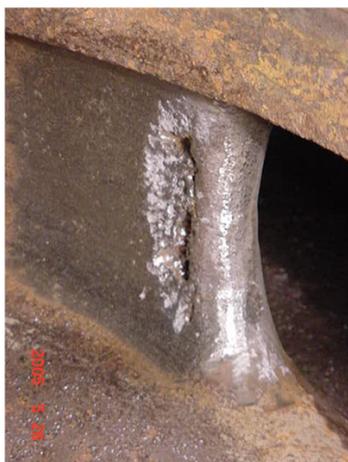
*The cut-water of this pump was damaged by erosion/cavitation and needed to be rebuilt and protected.*

- \* 1- Before application ,
- \* 2- Final application ,

The rebuilding step was done with Belzona 1311 in accordance to Belzona System Leaflet CEP-1. The area was then protected by overcoating with Belzona 1341.
