# Belzona extends the life of a CRF wheel

ID: 7896

Industry: *Power*  
Application: *CEP-Centrifugal Pumps*  
Substrate: *Cast iron*  
Products: *\* Belzona 2311 (SR Elastomer) ,*  
*\* Belzona 2141 (ACR-Fluid Elastomer) ,*

Customer Location: *France*  
Application Date: *2005*

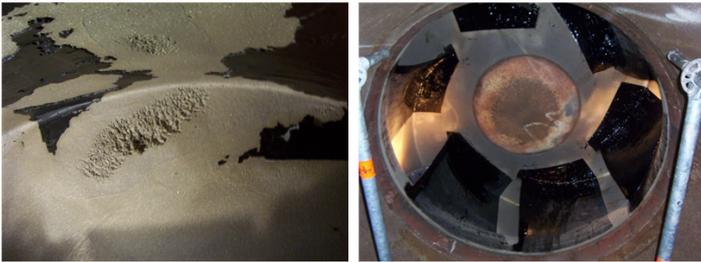
*The coating and the equipment were damaged by cavitation.*

- \* 1- Before application ,
- \* 2- After application ,

Blades on a CRF wheel in a nuclear power plant.

Application was carried out in accordance with Belzona System Leaflet CEP-05.

After the removal of the remaining patches of the previous coating, the substrate was rebuilt using Belzona 2311. Belzona 2141 was then used to protect the area against cavitation.

The customer noticed that the service life of this equipment was tripled thanks to this application. This solution would last 3 years instead of 1 with the alternatives tested before (welding, ceramic tiles, ...). This application is now done by the distributor every 3 years on this equipment.
