Belzona extends the life of a CRF wheel

Industry: *Power*
Application: *CEP-Centrifugal Pumps*
Substrate: *Cast iron*
Products: ** Belzona 2311 (SR Elastomer) ,*
** Belzona 2141 (ACR-Fluid Elastomer) ,*

Blades on a CRF wheel in a nuclear power plant.

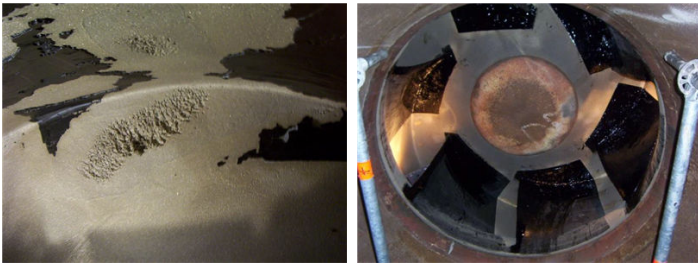
- * 1- Before application ,
- * 2- After application ,

The coating and the equipment were damaged by cavitation.

After the removal of the remaining patches of the previous coating, the substrate was rebuilt using Belzona 2311. Belzona 2141 was then used to protect the area against cavitation.
