Belzona repairs and protects a concrete pump volute on a water cooling system

ID: 7897

Industry: Power

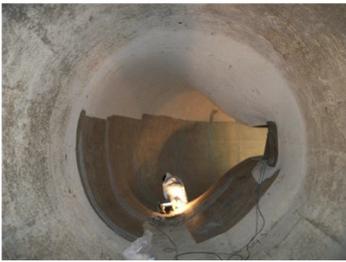
The pump volute presented cracks and wear and needed to be rebuilt before it would propagate.

- * 1- After the surface preparation, conditioner application ,
- * 2- Application of Belzona 4111 ,
- * 3- Final application ,

Application was carried out with an adapted version of Belzona System Leaflet FPA-01. After the surface preparation, the conditioner was applied and Belzona 4111 was used to rebuild the damaged area especially around the cutwater and all around the volute. Then, Belzona 1321 was used to protect the walls against erosion/corrosion.
