Belzona repairs and protects a concrete pump volute on a water cooling system

ID: 7897

Industry: Power

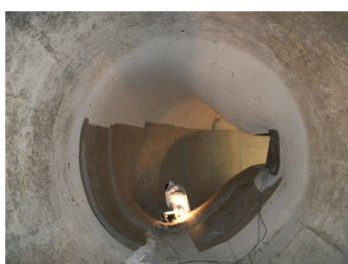
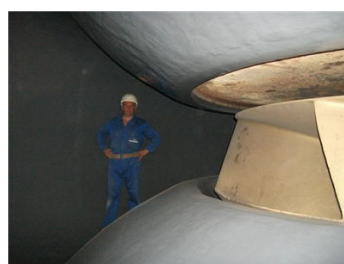
Photograph Descriptions

- * 1- After the surface preparation, conditioner application ,
- * 2- Application of Belzona 4111 ,
- * 3- Final application ,

Application was carried out with an adapted version of Belzona System Leaflet FPA-01. After the surface preparation, the conditioner was applied and Belzona 4111 was used to rebuild the damaged area especially around the cutwater and all around the volute. Then, Belzona 1321 was used to protect the walls against erosion/corrosion.
