# Belzona repairs and protects a concrete pump volute on a water cooling system

Industry: Power

Application: WPA-Wall Problem Areas

Application Date: September 2011

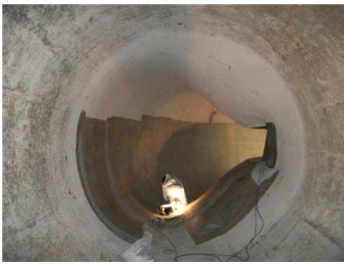
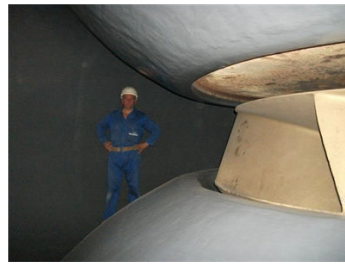
The pump volute presented cracks and wear and needed to be rebuilt before it would propagate.

- \* 1- After the surface preparation, conditioner application ,
- \* 2- Application of Belzona 4111 ,
- \* 3- Final application ,

Application was carried out with an adapted version of Belzona System Leaflet FPA-01. After the surface preparation, the conditioner was applied and Belzona 4111 was used to rebuild the damaged area especially around the cutwater and all around the volute. Then, Belzona 1321 was used to protect the walls against erosion/corrosion.
