Belzona protects an SEC filter in a nuclear power plant

Application: CEP-Centrifugal Pumps

The volute of an SEC filter

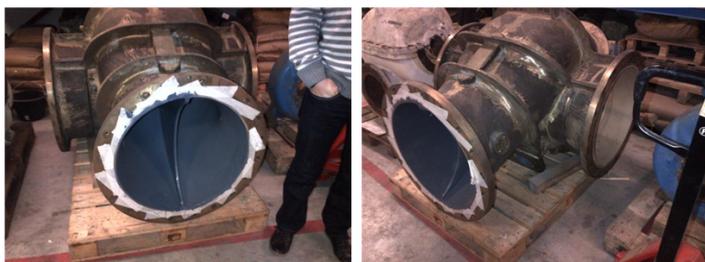
Photograph Descriptions

The volute of this SEC filter was damaged by erosion. The micro-porosity generated by the erosion resulted in the oxidation of the copper visible from the outside.

- * 1- Finished application ,
- * 2- Overview of the equipment ,

Application was carried out in accordance with Belzona System Leaflet CEP-5 After preparing the surface, 2 coats of Belzona 1321 were applied inside the filter (800 microns in total).

This product offered a good long-term protection against erosion and oxidation.
