Belzona repairs a vacuum pump casing and protects it against cavitation

Application: CEP-Centrifugal Pumps

Part of a casing on a vacuum pump

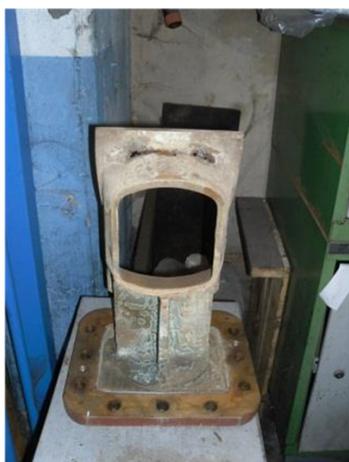
The casing of this pump was exposed to a severe cavitation causing important damages and perforations after only a few months.

Belzona 2311 was first used to rebuild the damaged area, then Belzona 2141 was used to protected the whole application against cavitation.
