# Belzona Rebuilds and Protects a Sulphuric Acid Tank

ID: 7900

Industry: General Industry  
Application: TCC-Tanks and Chemical Containment Areas

Customer Location: France  
Application Date: 2017

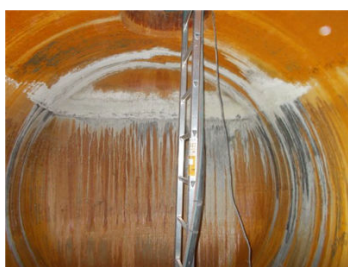
Due to the high concentration of sulphuric acid contained in this storage tank (98%), the walls were severely corroded, causing an unn loss of thickness.

- \* Before surface preparation ,
- \* After surface preparation ,
- \* Final application ,
- \* Final application ,

The inside of the tank was first grit blasted, then Belzona 1121 was used to recover the loss of thickness. Then Belzona 4311 was used to protect the whole internal surface of the tank against sulphuric acid. This application was carried out in accordance with a modified version of Belzona Kow-How System Leaflet TCC-05.
