# Belzona Restores the Sealing of a Butterfly Valve

ID: 7901

Disk of a butterfly valve situated within a pipe of an air-condenser.

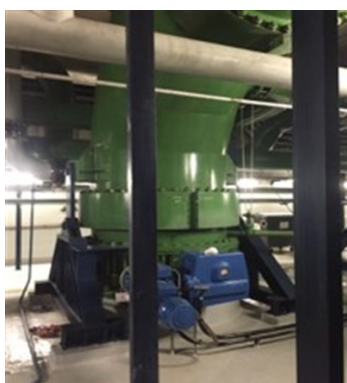
The erosion in the pipe damaged the rubber coating causing a seal to no longer operate correctly as it no longer sat flush with the surface.

- \* Overview of the pipe ,
- \* After surface preparation ,
- \* During the application ,
- \* Final application ,
