# Belzona restores a pump from a nuclear power plant

Application: CEP-Centrifugal Pumps

Application Date: October 2017

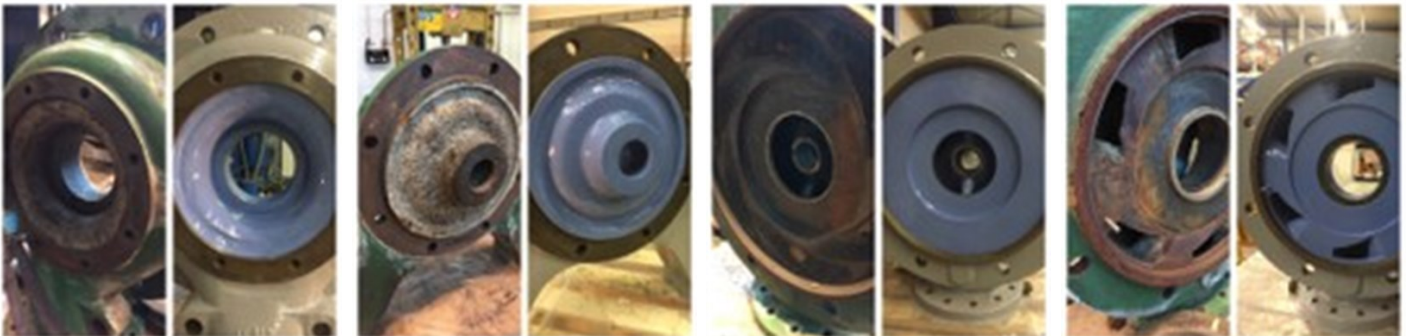
The substrate was badly damaged by corrosion and erosion and needed to be rebuilt and protected

- \* 1- Pump 1 Before/After ,
- \* 2- Pump 2 Before/After ,
- \* 3- Pump 3 Before/After ,
- \* 4- Pump 4 Before/After ,

Pump internal surface

The application was carried out in accordance with Belzona System Leaflet CEP-1.

The substrate was first prepared by grit blasting. Then, Belzona 1311 was used to rebuild the damaged areas. Belzona 1341 was finally used on the whole internal surface to provide a protection against corrosion and erosion.
