Belzona Saves Impeller After Chemical Exposure

ID: 7907

Industry: *General Industry*
Application: *CEP-Centrifugal Pumps*
Substrate: *Mild Steel*
Products: ** Belzona 1311 (Ceramic R-Metal) ,*
** Belzona 4311 (Magma CR-1) ,*
** Belzona 9111 (Cleaner/ Degreaser) ,*

Customer Location: *Bristol, UK*
Application Date: *Feb 2019*

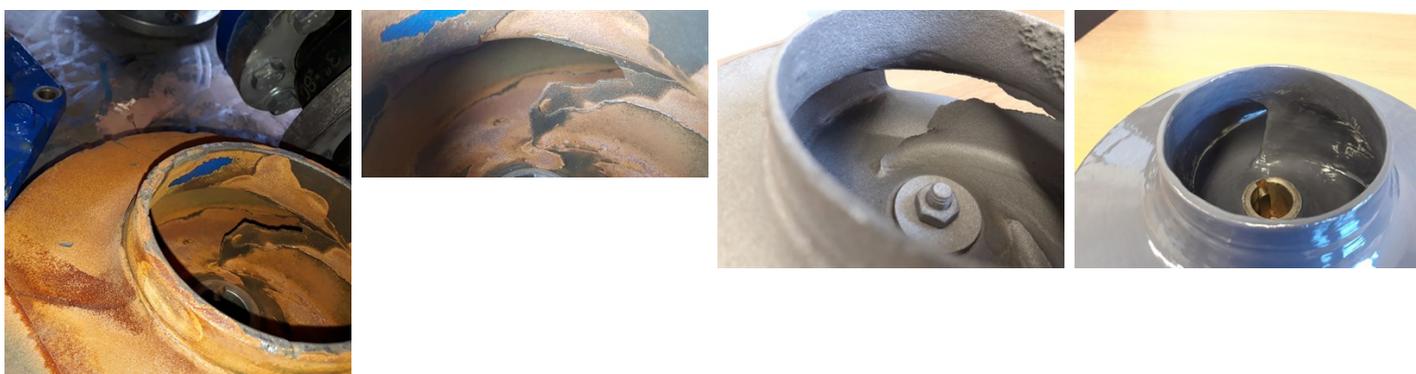
Photograph Descriptions

A pump and impeller were badly damaged by accidental contamination with sulfuric acid at 20% concentration. Lead time for a new unit was 12 weeks, leaving the end user with an expensive period of prolonged downtime. The impeller needed rebuilding to make it operational, and then coating to protect from any further incidental contact.

- * 1- Corroded impeller ,
- * 2- Close up of interior damage ,
- * 3- Profile after grit blasting ,
- * 4- Completed repair after coating ,

A circulation pump required its impeller rebuilding after it became worn through accidental acid exposure.

Substrate was grit blasted to 75 microns and cleaned to SA 2.5. The damaged areas of the impeller were then rebuilt, to as near to the original profile as possible, using Belzona 1311. Some areas were required rebuilding due to the extensive damage. Once the Belzona 1311 had cured, two coats of Belzona 4311 were applied to protect against further incidental contact. This was completed in accordance with Belzona System Leaflet CEP-1.

Due to the long lead time of a replacement, rebuilding the impeller was the only option to get the customer up and running as quickly as possible. The rebuild was a complete success and the customer was delighted with the standard of work which such a fast turn around.
