Belzona Installs a New Drain Nozzle on a Phosphoric Acid Storage Tank

ID: 7908

Application: *TCC-Tanks and Chemical Containment Areas*

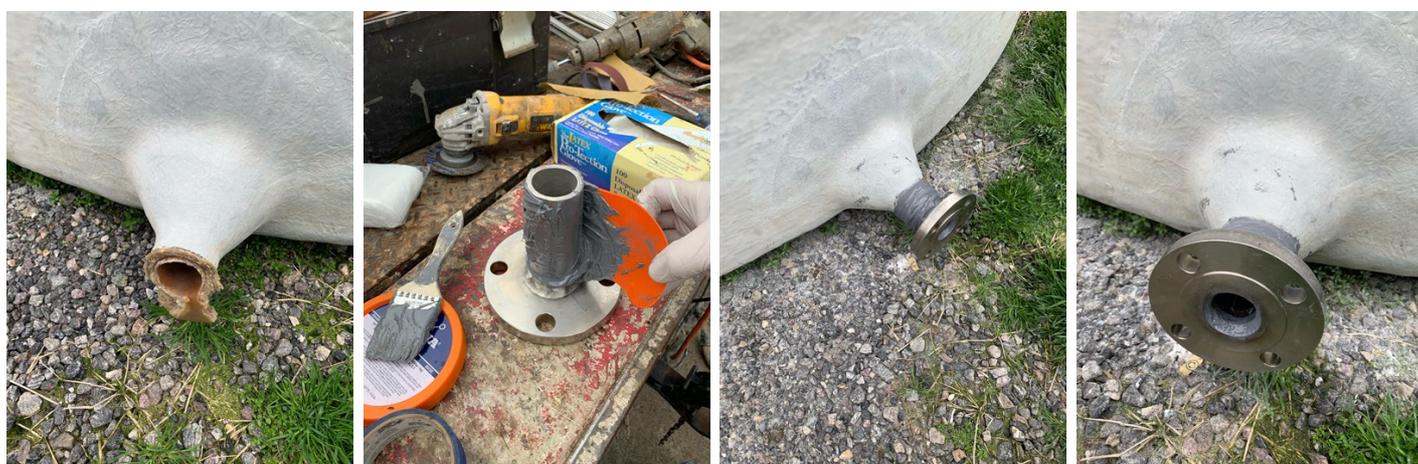
The drain nozzle broke off a tank that stores phosphoric acid.

- * 1. Broken off nozzle. ,
- * 2. Applying Belzona 4301 to the new nozzle ,
- * 3. The new nozzle inserted ,
- * 4. Complete application ,

Drain nozzle on a 54% phosphoric acid storage tank.

A replacement nozzle and a flange were fabricated. Belzona 4301 was applied to the new nozzle and inside the old nozzle. A new nozzle was then inserted, and bolt holes were lined up. Belzona 9341 was used was applied around the joint area to secure it in place, and encapsulates with an additional coat of Belzona 4301.
