# Split pump keeps it cool with Belzona

Industry:	Fluid Flow
Application:	CEP-Centrifugal Pumps
Substrate:	Carbon Steel
Products:	* Belzona 1311 (Ceramic R-Metal) ,
	* Belzona 1812 (Ceramic Carbide FP) ,
	* Belzona 1321 (Ceramic S-Metal) ,

Customer Location: Huelva - Spain Application Date: 2017

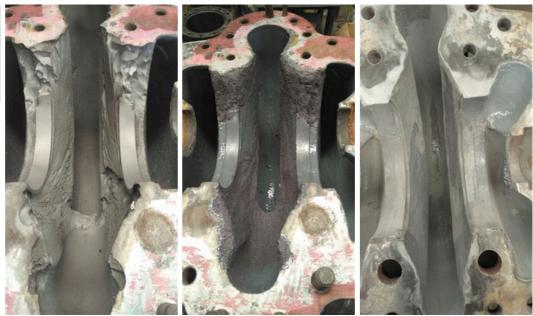
Heavy erosion caused by suspended particles in the fluid.

- \* 1. Pump after 10 years in service (some Belzona 1321 still visible),
- \* 2. Wear ring seating areas rebuild with Belzona 1311,
- \* 3. Most severely worn areas rebuild and protected with Belzona 1812,
- \* 4. Remaining areas rebuild with Belzona 1311 & coated with Belzona 1321,

10 years after Belzona 1321 was applied to the split case pump, the coating is now almost completely gone and erosion has removed some of the steel. The customer was happy with the performance of Belzona and wished to utilize Belzona materials to further extend the life of this pump.

The application was carried out in accordance with Belzona System Leaflets CEP-2, CEP-3 & CEP-5.
