Belzona has what it takes to stop the acid leak

ID: 7911

Industry: Chemical & Petrochemical
Application: VPF-Valves, Pipes and Fittings
Substrate: Steel
Products: * Belzona 4301 (Magma CR1 Hi-Build),

Customer Location: Huelva - Spain
Application Date: June 2018

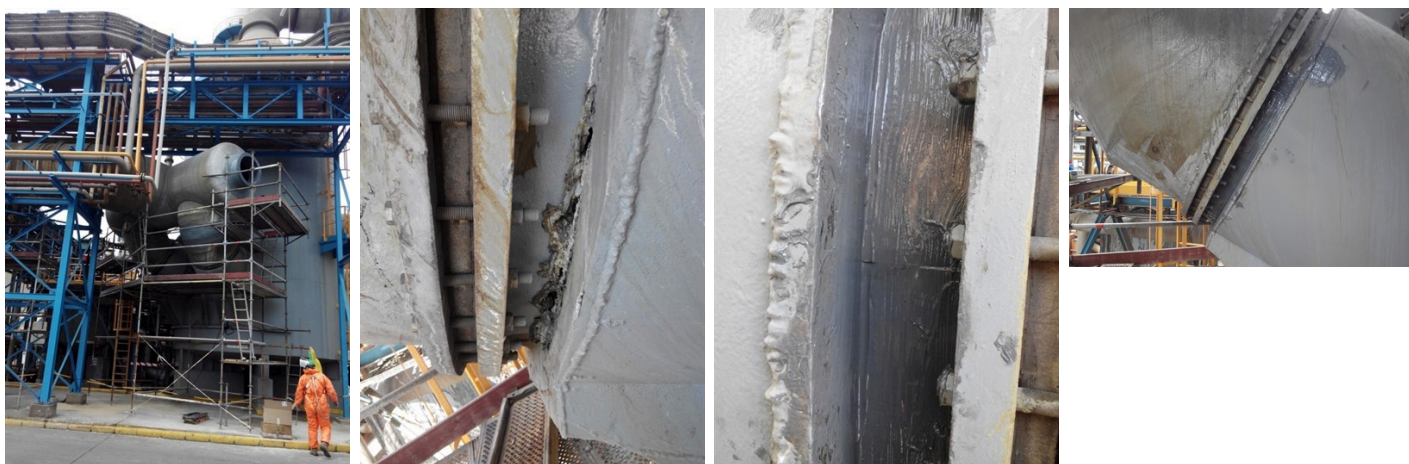
In the gas suction line condensation of the acids on the internal surface has caused severe corrosion, leading to leaks, which are hazardous to the surrounding environment.

- * 1. Location of equipment within the acid plant ,
- * 2. Close up of defect ,
- * 3. Belzona 4301 being applied ,
- * 4. Completed repair ,

Application is carried out using a modified version of Belzona System Leaflet VPF-11. The surface was prepared using mechanical tools and was cleaned with acetone to remove surface contaminants.

not permitted without special measures being put in place, which are undesirable to the customer. Belzona 4301 has the required chemical resistance to stand up to the 98% sulfuric acid, and can be applied quickly and easily, making it a convenient and effective solution.
