# Belzona SuperWrap II Seals Deteriorated Pipe Coupling

ID: 7912

Customer Location: Natural gas power plant, California, USA  
Application Date: November 2018

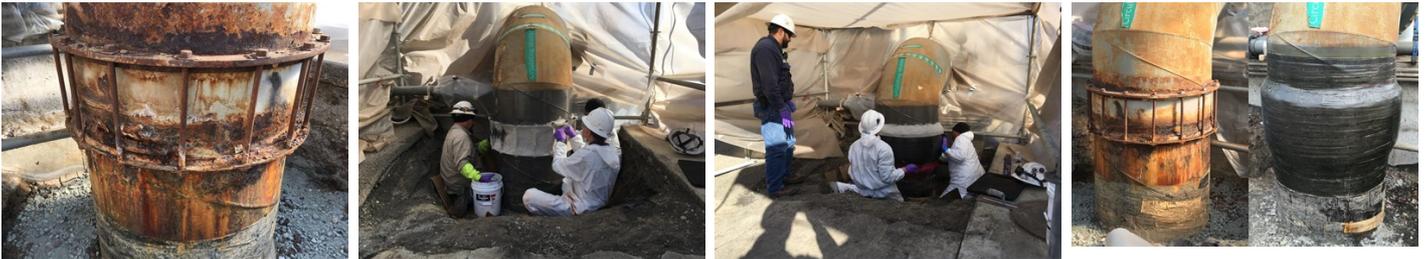
The pipe coupling was buried and therefore suffered severe corrosion below the ground.

- \* Damaged coupling. ,
- \* Application of Belzona 4141. ,
- \* Application of Belzona Superwrap II. ,
- \* Complete Application: Before & After ,

Flange coupling connecting a 32" cooling water bypass line for the power plants cooling tower.

The application took place during the plant's regular shutdown. The whole procedure including set up, surface preparation, application and clean up took 3 days. A tent enclosure was built and grit blasting was carried out by a contractor on the first day with a final frost blast early morning on the second day. The application was performed by the customers maintenance team. The bulk fill with Belzona 4141 and the first layer of Belzona 1982 SuperWrap II was done on the second day. After a detergent wash of the wrap and surface preparation of the first wrap, the second and third layer had been applied on the third and final day of the application. Each layer of the wrap has been individually consolidated with Belzona 9382 release film. The application was carried out in accordance with a modified version of Belzona Know-How System Leaflet - VPF-14.
