# Primary Crusher Base Repaired with Belzona 4111 and Belzona 4151

Industry: Mining & Quarrying  
Application: RPA-Roof Problem Areas  
Substrate: Concrete

Customer Location: Copper Mine, Brazil  
Application Date: 2018

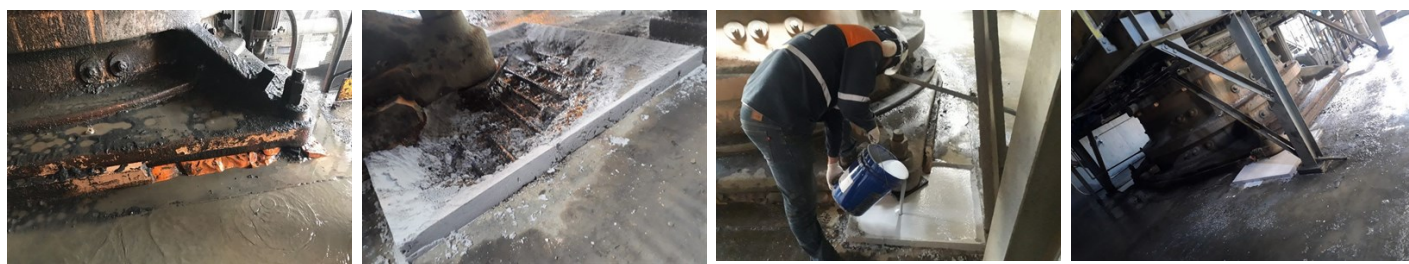
Excessive vibration of the crusher caused the concrete base to crack which could potentially compromise the functionality of the machinery.

\* Damaged base of the crusher. The perimeter of the base rebuilt with a regular mix of Belzona 4111. A fluid mixture of Belzona 4111 and Belzona 4151 resin used to fill in the void and have it self-level in the base. Foundation of primary crusher repaired with Belzona 4111 and Belzona 4151 ,

Using an impact hammer drill, the first two layers of concrete were removed to reach the steel reinforcement structure. Prior to application of Belzona 4911 (Magma TX Conditioner), area was cleaned and degreased with a solvent, compressed air was also used to have the entire repair area free of loose debris and dust. The perimeter of the repair area was rebuilt with a regular mix of Belzona 4111, and after that, a fluid mix of Belzona 4111 with extra Belzona 4151 was used to fill the void and self-level the base of the equipment.
