Belzona Delivers Critical Solution Using Rope Access

Customer Location: Water Taxi Service, Trinidad and Tobago

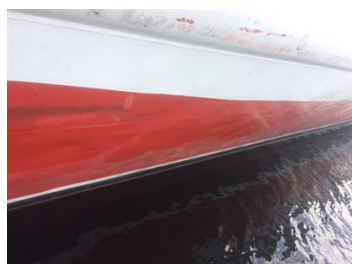
The ferry had sustained a series of dents on its starboard side above the water line. One of the dents was perforated. The boat had recently come out of dry dock in preparation for certification and it was virtually impossible to send it back to dry dock given the cost and the tight timeline to commission it.

* Damaged areas on the starboard side of the ferry. Perforated dent area. A technician at work on a rope access. Complete application. ,

The solution involved Rope Access to apply Belzona 1111 and Belzona 9341 to rebuild the dents and seal the perforation. The application was carried out in accordance with modified versions of Belzona Know-How System Leaflets SOS -1 and SOS -2. We accessed the repair area via a 4-man rope access team. Surface preparation was performed using an MBX. The customer had their Project Manager on site and the service provider had a NACE – 2 Inspector.
