Belzona Delivers Critical Solution Using Rope Access

Industry: Marine

Customer Location: Water Taxi Service, Trinidad and Tobago

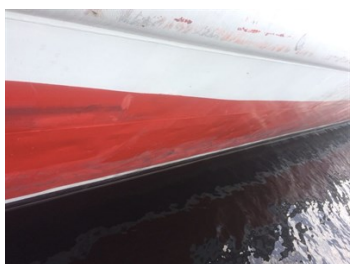
The ferry had sustained a series of dents on its starboard side above the water line. One of the dents was perforated. The boat had recently come out of dry dock in preparation for certification and it was virtually impossible to send it back to dry dock given the cost and the tight timeline to commission it.

* Damaged areas on the starboard side of the ferry. Perforated dent area. A technician at work on a rope access. Complete application. ,

The solution involved Rope Access to apply Belzona 1111 and Belzona 9341 to rebuild the dents and seal the perforation. The application was carried out in accordance with modified versions of Belzona Know-How System Leaflets SOS -1 and SOS -2. We accessed the repair area via a 4-man rope access team. Surface preparation was performed using an MBX. The customer had their Project Manager on site and the service provider had a NACE – 2 Inspector.
