# Belzona 1812 Applied Inside Small-Diameter Pipes

ID: 7926

Industry: *Mining & Quarrying*  
Application: *SHM-Solids Handling Machinery*

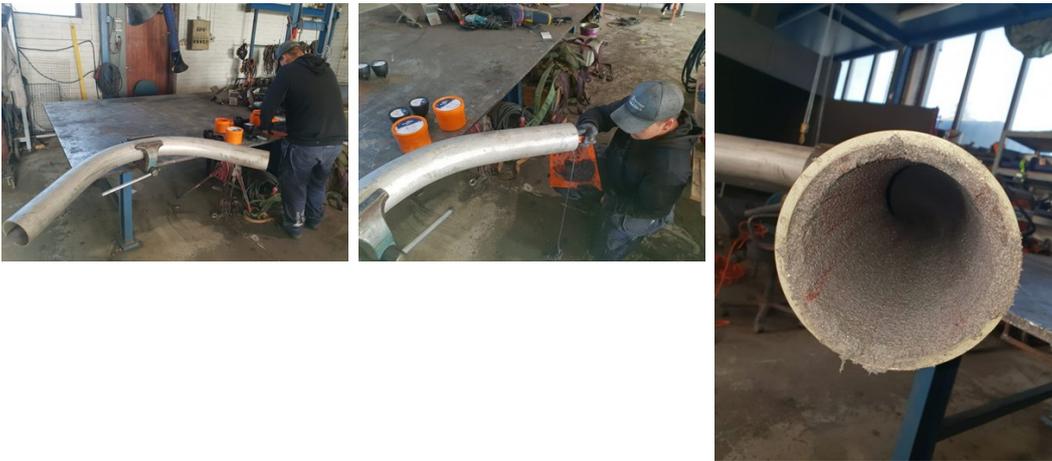
*Hard abrasion from rock and mineral dust wore out long pipes with small orifice-diameters which led to a long downtime. Repairs and new installations were often required.*

- \* 1. The pipe to be repaired ,
- \* 2. The application of Belzona 1812 underway ,
- \* 3. Application complete before dressing back ,

To be able to apply Belzona 1812 inside a 2-meter long and 100mm diameter pipe bend, the contractor used a similar punch-tool as they use when applying a rubber surface into pipes. The punch-tool was pulled through the pipe with a wire and Belzona 1812 was pressed onto the sides of the pipe. Using different sizes, a sufficient thickness has been achieved. The application was completed in accordance with a modified version of Belzona Know-How System Leaflet SHM-08.
