# Belzona Protects Brand New Fertilizer Plant

Industry: *Other*  
 Application: *TCC-Tanks and Chemical Containment Areas*  
 Substrate: *Concrete*  
 Products: *Belzona 4311 (Magma CR1),  
 Belzona 4151 (Magma-Quartz Resin),*

Customer Location: *Hungary*  
 Application Date: *2007*

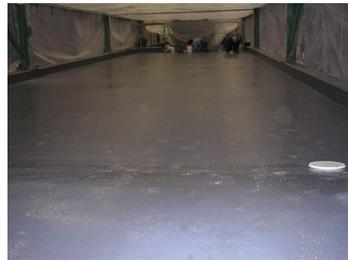
Application area being tented out

Application was carried out in accordance with Belzona Know-How system Leaflets TCC-15 and TCC-08. The outside area was tented out and the new concrete was coated with Belzona 4311. A special mortar mix of Belzona 4151 and AL203 ceramic aggregate was made for the 2 pads for the tractors feet to rest on, yellow tinted Belzona 4151 safety lines were also applied to help the driver park the tractor easily.

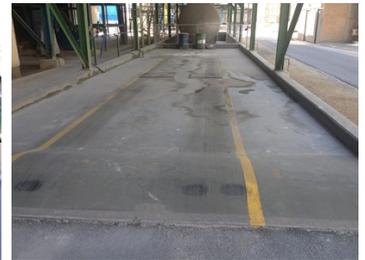
Coated fertiliser plant area

Over the years it was found that when the tractor picked up the tanker it would push it 10-20 cm backwards, damaging the Belzona 4311 coating with it's metal feet. To prevent this 2 wear pads were mixed and applied. 8 years later and the system is still in good condition.
