Belzona Repairs Cement Plants Rotary Dryer

Industry: *Cement*

Application: *SHM-Solids Handling Machinery*

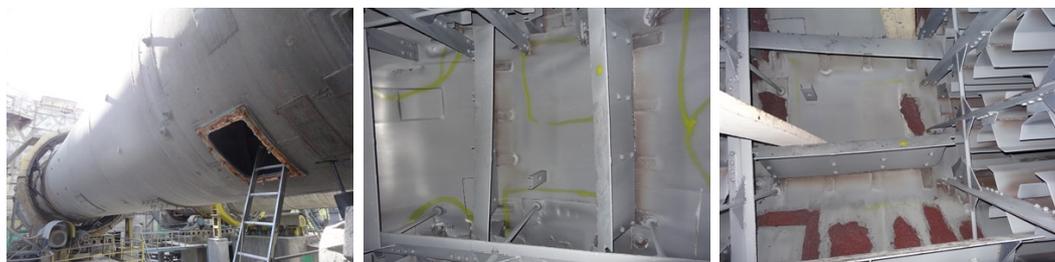
Photograph Descriptions

The rotary dryer (15 m long and 3.6 m diameter) is used for slag drying. The drying cylinder has an angle against the horizontal level and rotates while running. After putting the slag into one end of the rotary dryer, the slag is dispersed uniformly and forms a material curtain in the cylinder to contact the hot air (100°C), which acts like a heat exchanger to achieve slag drying. In the area where the lifting flights are installed onto the interior of the dryer, the slag erodes the steel, eating away up to 15 mm of the metal from the original 20 mm thickness of the shell.

- * 1. Entrance to the dryer ,
- * 2. The view of the eroded area ,
- * 3. The eroded areas rebuilt with Belzona 1811 ,

After proper surface preparation, the application was carried out in accordance with a modified version of Belzona Know-How System Leaflet SHM-13. ☑ Belzona 1811 was used to fill in eroded small areas.

The customer stated that the Belzona repair material was much less costly than replacing the shell and importantly the application was completed within one day. The application was recently inspected (2019) and the original Belzona 1811 was in the same condition as the day the application was completed, more than 18 months prior. As a result, the customer asked Belzona for several
