# Belzona Repairs Cement Plants Rotary Dryer

ID: 7930

Internal deterioration of a dryer shell at a cement plant.

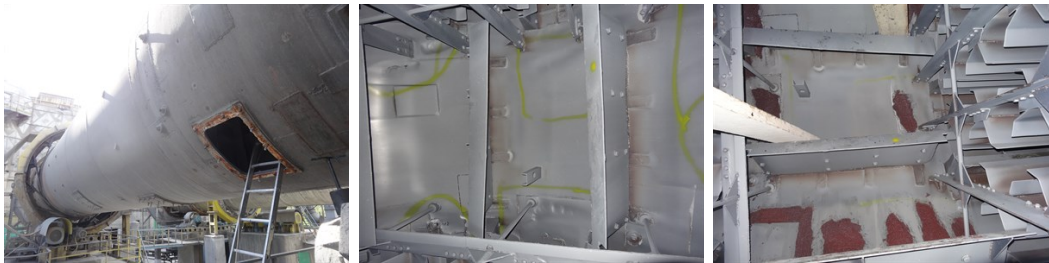
The rotary dryer (15 m long and 3.6 m diameter) is used for slag drying. The drying cylinder has an angle against the horizontal level and rotates while running. After putting the slag into one end of the rotary dryer, the slag is dispersed uniformly and forms a material curtain in the cylinder to contact the hot air (100°C), which acts like a heat exchanger to achieve slag drying. In the area where the lifting flights are installed onto the interior of the dryer, the slag erodes the steel, eating away up to 15 mm of the metal from the original 20 mm thickness of the shell.

- \* 1. Entrance to the dryer ,
- \* 2. The view of the eroded area ,
- \* 3. The eroded areas rebuilt with Belzona 1811 ,

After proper surface preparation, the application was carried out in accordance with a modified version of Belzona Know-How System Leaflet SHM-13. ☐ Belzona 1811 was used to fill in eroded small areas.

The customer stated that the Belzona repair material was much less costly than replacing the shell and importantly the application was completed within one day. The application was recently inspected (2019) and the original Belzona 1811 was in the same condition as the day the application was completed, more than 18 months prior. As a result, the customer asked Belzona for several
