# BELZONA STOPS STRESS CORROSION CRACKING

ID: 7932

**Industry:** Oil & Gas  
**Application:** TCC-Tanks and Chemical Containment Areas  
**Substrate:** Steel  
**Products:** \* Belzona 1111 (Super Metal) ,  
 \* Belzona 1591 (Ceramik XHT) ,

**Customer Location:** Egypt  
**Application Date:** 2018

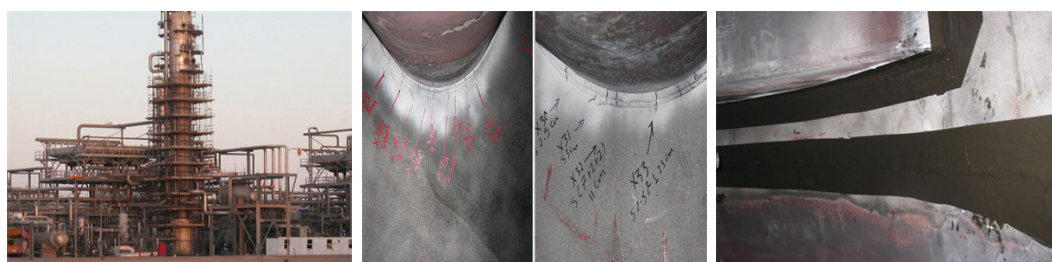
The column was suffering from dozens of cracks due to stress corrosion cracking (SCC) and some of them were leaking.

- \* 1 - The site ,
- \* 2 - The cracking ,
- \* 3 - The completed Belzona 1591 ,

Belzona 1591 was applied over the cracked areas to eliminate further cracks formation and Belzona 1111 was used to repair the leaking cracks from outside. Copper wire brush was the only suitable surface preparation tool due to the presence of flammable material. This application was completed in accordance with a modified version of Belzona System Leaflet TCC-01.

Hot work was not an option due to flammable material inside the column and the large number of cracks. The plan was to replace the column after 6-8 months but Belzona's performance was exceptional. It stopped the leakage and no further SCC was observed. The column is still in operation after 5 years.
