# Belzona alters yacht window frames with ease

Industry: Marine  
Application: GSS-Gaskets, Seals and Shims  
Substrate: Steel  
Products: \* Belzona 1121 ,

Customer Location: Mallorca  
Application Date: June 2018

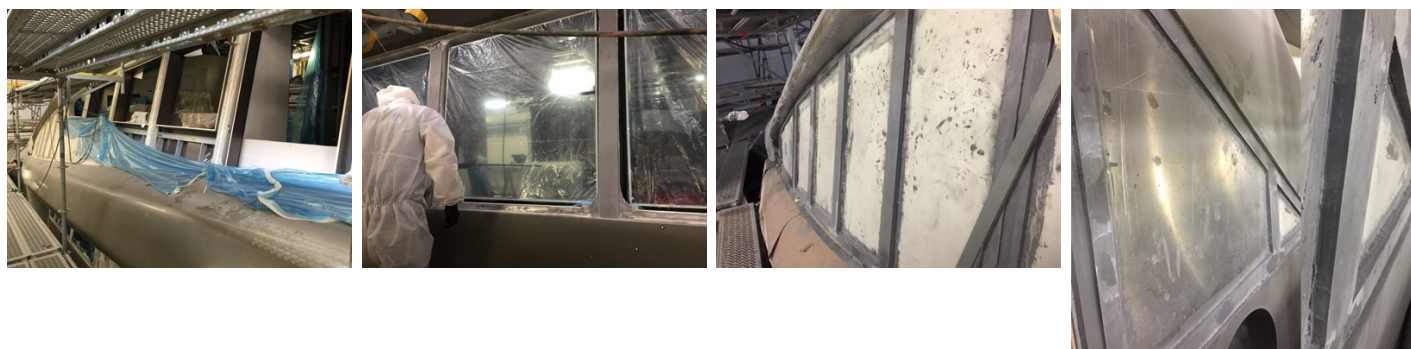
Due to a last minute design change affecting the thickness of the installed glass, the window frames had to be modified. As the structure had already been built, it was not possible to alter the structural design, and therefore an after market alteration had to be made so that the window frames could accommodate the lower thickness windows.

- \* 1. General view of window frames ,
- \* 2. Surface being prepared for application ,
- \* 3. Belzona applied with formers in place ,
- \* 4. Completed application ,

The application was carried out in accordance with a modified version of Belzona System Leaflet GSS-9. Belzona 1121 was used to build up the thickness of the window frames by 1 - 1.5 cm. A forming technique was used to ensure precise tolerances. Belzona 9411 (Release Agent) was applied to the formers so that they could be easily removed after the Belzona 1121 had cured.

Belzona 1121 was selected due to its high build capability, allowing the required thickness to be added to the window frames in a single application. The Belzona material is 100% solids, meaning that it will not distort or shrink whilst curing. This is essential to ensure the correct tolerances can be met. Welding was considered, but rejected as it was deemed the heat stresses could damage
