VACUUM OVEN REPAIR WITH 900KG OF BELZONA 1593

Industry: Chemical & Petrochemical
Application: TCC-Tanks and Chemical Containment Areas

Customer Location: Bratislava, Slovakia
Application Date: 2017

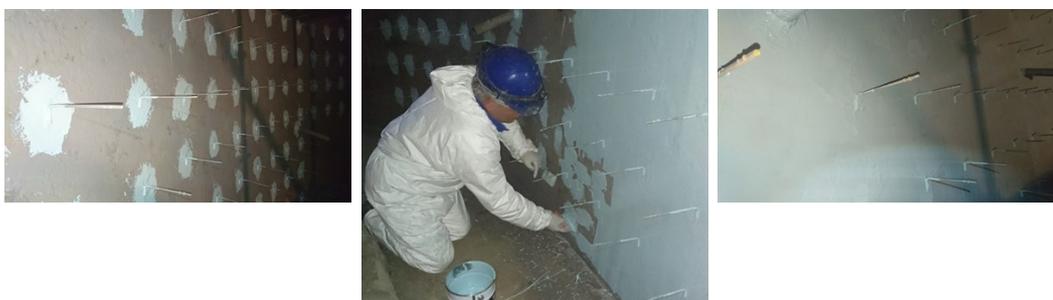
Photograph Descriptions

- * 1. Coating of the steel prickles ,
- * 2. The first coat of Belzona 1593 being applied ,
- * 3. 2nd coat of Belzona 1593 applied ,

After blasting and cleaning, the oven was divided into 8 stages and there were 3 workers prepared for every stage. Together with assistant workers (mixing, transport and safety, among others) there were 30 people at once (in cooperation with the Czech Belzona team). The first coat of Belzona 1593 was applied at 375 microns. The steel prickles made the application complicated and as the customer wanted them coated also, it was not so easy. After 12 hours the second coat was applied at 375 microns. Complete coating was finished in 2 days. The application was performed in accordance with Belzona system leaflet TCC-5.
